The Conservation of Church Tiles

Lesley Durbin BA (hons) ACR
Senior Conservator, Jackfield Conservation Studio Ltd

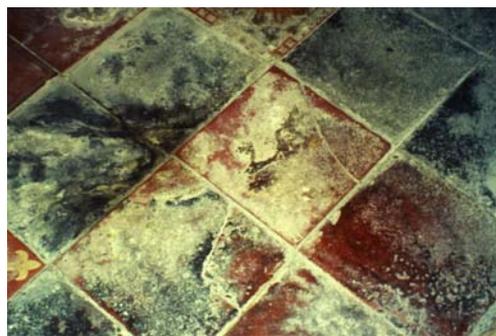
Figure 1

Salts of various types are naturally present in either the tile body itself or the underlying substrate, whatever it may be, or in both. For the most part they will remain as soluble salts and do no harm as long as both the tile and the substrate remain in a stable atmosphere, either humid or dry. If rapid changes of humidity or temperature occur, as is often the case in churches when heating is turned on or off frequently, then the soluble salts will begin to re-crystallize (Fig. 1). Damaging salt

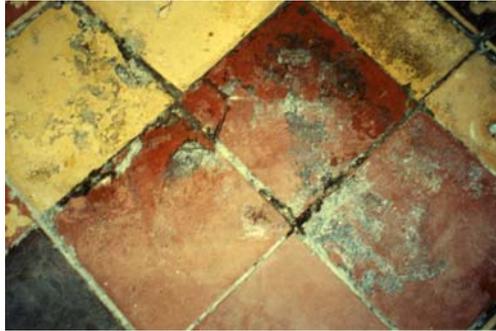
Figure 2

crystals can appear on the surface or even within the clay body of the tile caused by low or incomplete evaporation of rising ground water. This slow evaporation can also cause a chemical change within the clay resulting in the appearance of black sulphides, which will permanently stain the tile (Fig. 2). Covering tiles with carpets

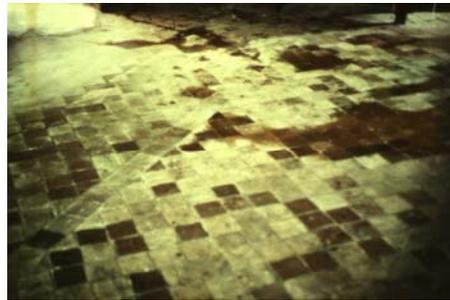
Figure 3

when these combinations of conditions are prevalent is also a recipe for disaster, as the moisture in the tiles will not have the opportunity to regularly dry with a free passage of air over the surface (Fig. 3). To remedy this situation the ambient

temperature and humidity in the building must be constant along with a good airflow, in addition the tile floors should be cleaned regularly.

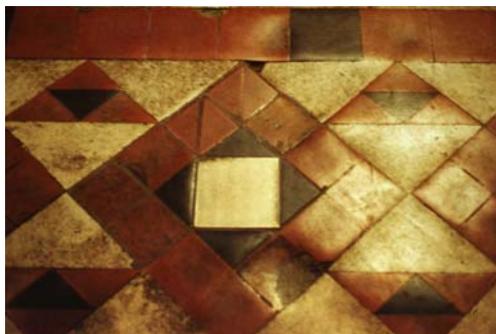
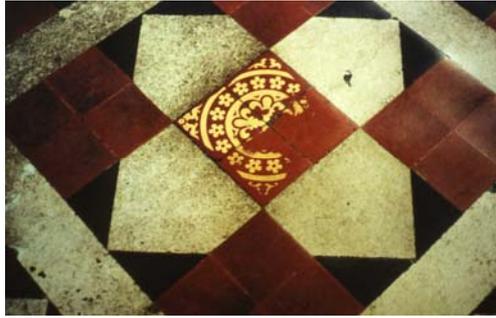
The tread of many feet over a long period of time in a relatively small area such as an entrance or central nave aisle, will inevitably result in severe wear and tear (Figs. 4 and 5). In some instances tiles can be completely worn away giving rise to what

would be considered a hazard in health and safety terms, in others it merely results in the loss of decorative pattern. In the first case the worn tiles must be removed and replaced as soon as possible, however it is vital from an aesthetic point of view that the new tiles must match the historic exactly in colour and size. In the second case replacement is not essential; it is a matter of judgement as to the level of restoration or conservation to be achieved whether to leave the original but worn tile in place or to put in an 'as new' replacement.

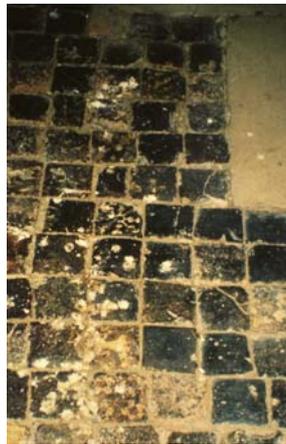
Figure 6

Medieval tiles are rarely found in churches now, but when they do occur they require special treatment. They should be cleaned only very rarely, perhaps annually, and then only by a conservator. Bird droppings must not be allowed to gather in any one place, under nesting swallows is a particularly common occurrence, the acid surface environment caused by droppings can be very damaging therefore they must not be allowed to accumulate (Fig. 6). The traditional

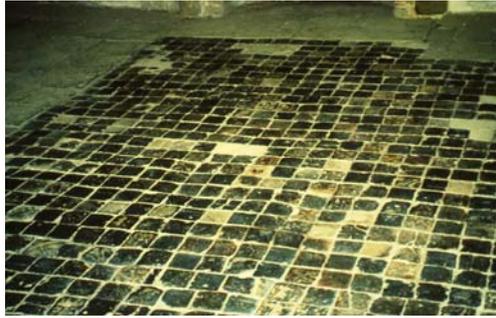
Figure 7

coating for tiles in the past was either hot linseed oil or beeswax, as time goes by the oil or wax will blacken as it both absorbs dirt and naturally changes colour; both wax and linseed oil are virtually impossible to remove. Neither is recommended as coatings. Repairs to medieval floors should always be of the simplest form using lime mortar (Fig. 7).

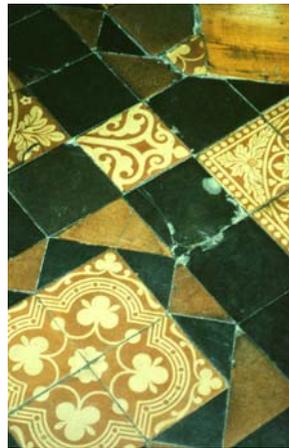
Figure 8

Typically fractures, together with spalling on the edges of tiles, are caused by building shift, the movement causing pressure as the tiles are forced against each other. This type of damage usually occurs when tiles are laid on Portland cement, lime mortar is more forgiving and will accommodate movement more readily (Fig. 8). Often in the past damaged tiles will have been repaired with unsympathetic,

badly matched tiles. The remedy here is to cut out the damaged and poorly matched tiles and replace with new tile where the pattern can be correctly re-ordered and the colours matched. However it is important to be circumspect in the number of tiles to be replaced making sure the maximum number of historic tiles remain in place (Fig. 9). There are instances where previous re-ordering of the church or provision of services result in ugly cement infills (Fig. 10). The best remedy here is to buy new matching tiles and have them fixed by a skilled craftsman tile fixer.

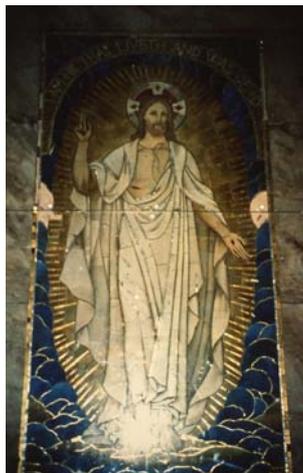
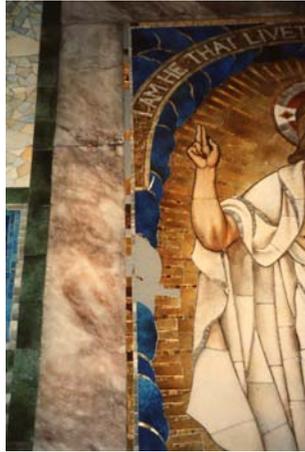
Many churches are poorly provided for in terms of funding in order to maintain and care for their valuable historic fabric. A great deal of damage can be done by poor workmanship or bad practices during repairs. Poorly thought out procedures can cause irreparable damage, which is inevitably more costly than ever to put right (Figs. 11 and 12). Parish Church Councils and their architects now have a duty of
